**UNITED STATES DEPARTMENT OF LABOR  
MINE SAFETY AND HEALTH ADMINISTRATION  
COAL MINE SAFETY AND HEALTH**

**REPORT OF INVESTIGATION**

**Fatal Underground Mine Explosion  
April 5, 2010**

**Upper Big Branch Mine-South, Performance Coal Company  
Montcoal, Raleigh County, West Virginia, ID No. 46-08436**

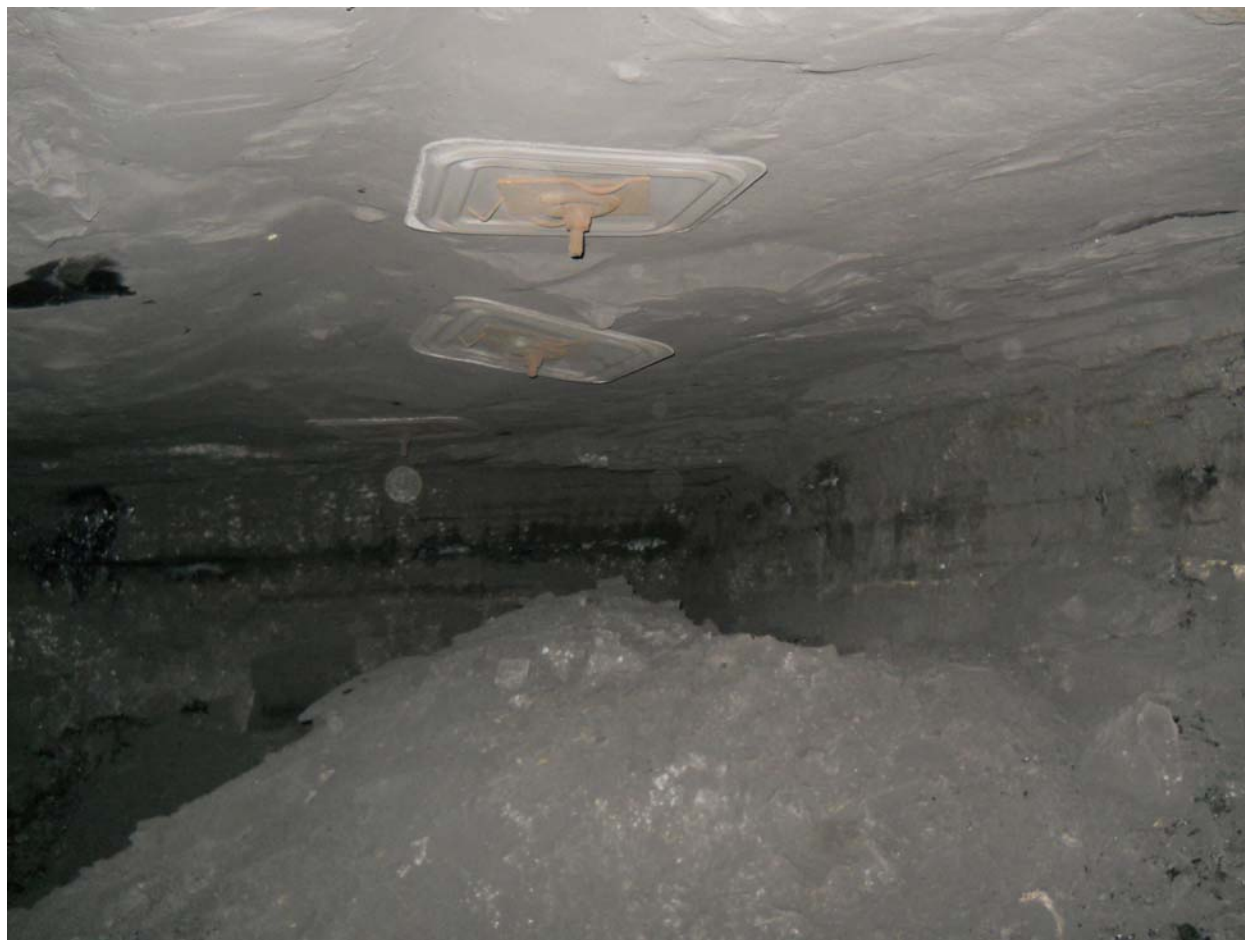
the explosion. Miners working in these areas testified these accumulations existed prior to the explosion.

Figure 3. Accumulations of loose coal, coal dust, and float coal dust were measured up to 7 feet wide by 12 feet long by up to 4 feet in depth. These were found consistently along every single air course.

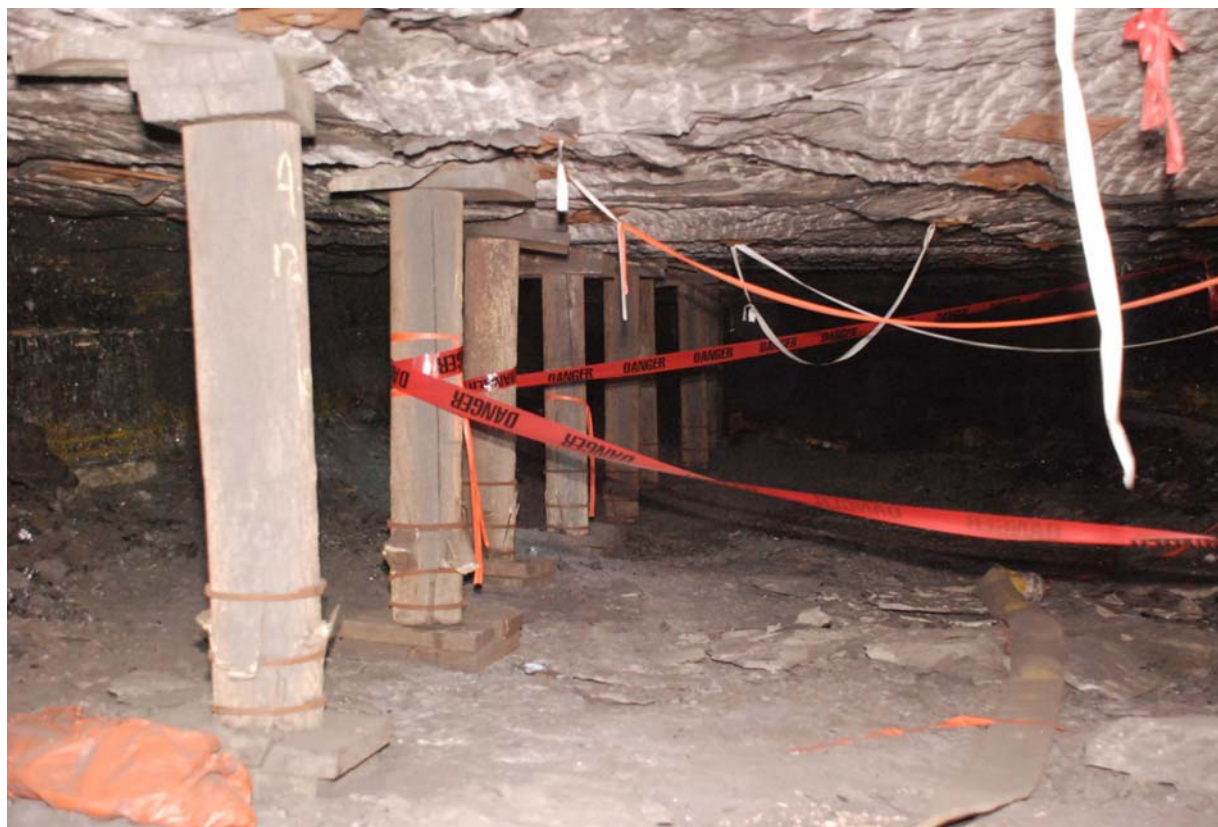
PCC's roof control plan required two rows of posts or two 8' cable bolts in the No. 7 entry in the longwall tailgate as supplemental support. This requirement was intended to maintain adequate roof support in that entry. PCC only installed one row of posts in the entry as shown in Figure 4. Both the single row of posts and the resulting roof control issues were obvious; examiners testified that they did not like to travel in that entry due to the bad top. PCC never recorded the hazard in any of its examination books. Poor roof conditions led to a roof fall in the No. 7 entry, which likely restricted air flow coming off the longwall face, and allowed methane to accumulate prior to the explosion. The investigation indicated that this fall was present prior to the explosion; blackened dust from the explosion was present on the fall and could only have occurred after the explosion.

Figure 4. Photograph of Tailgate 1 North No. 7 entry showing only one row of posts installed. The approved roof control plan required two rows of 8' cable bolts or posts.

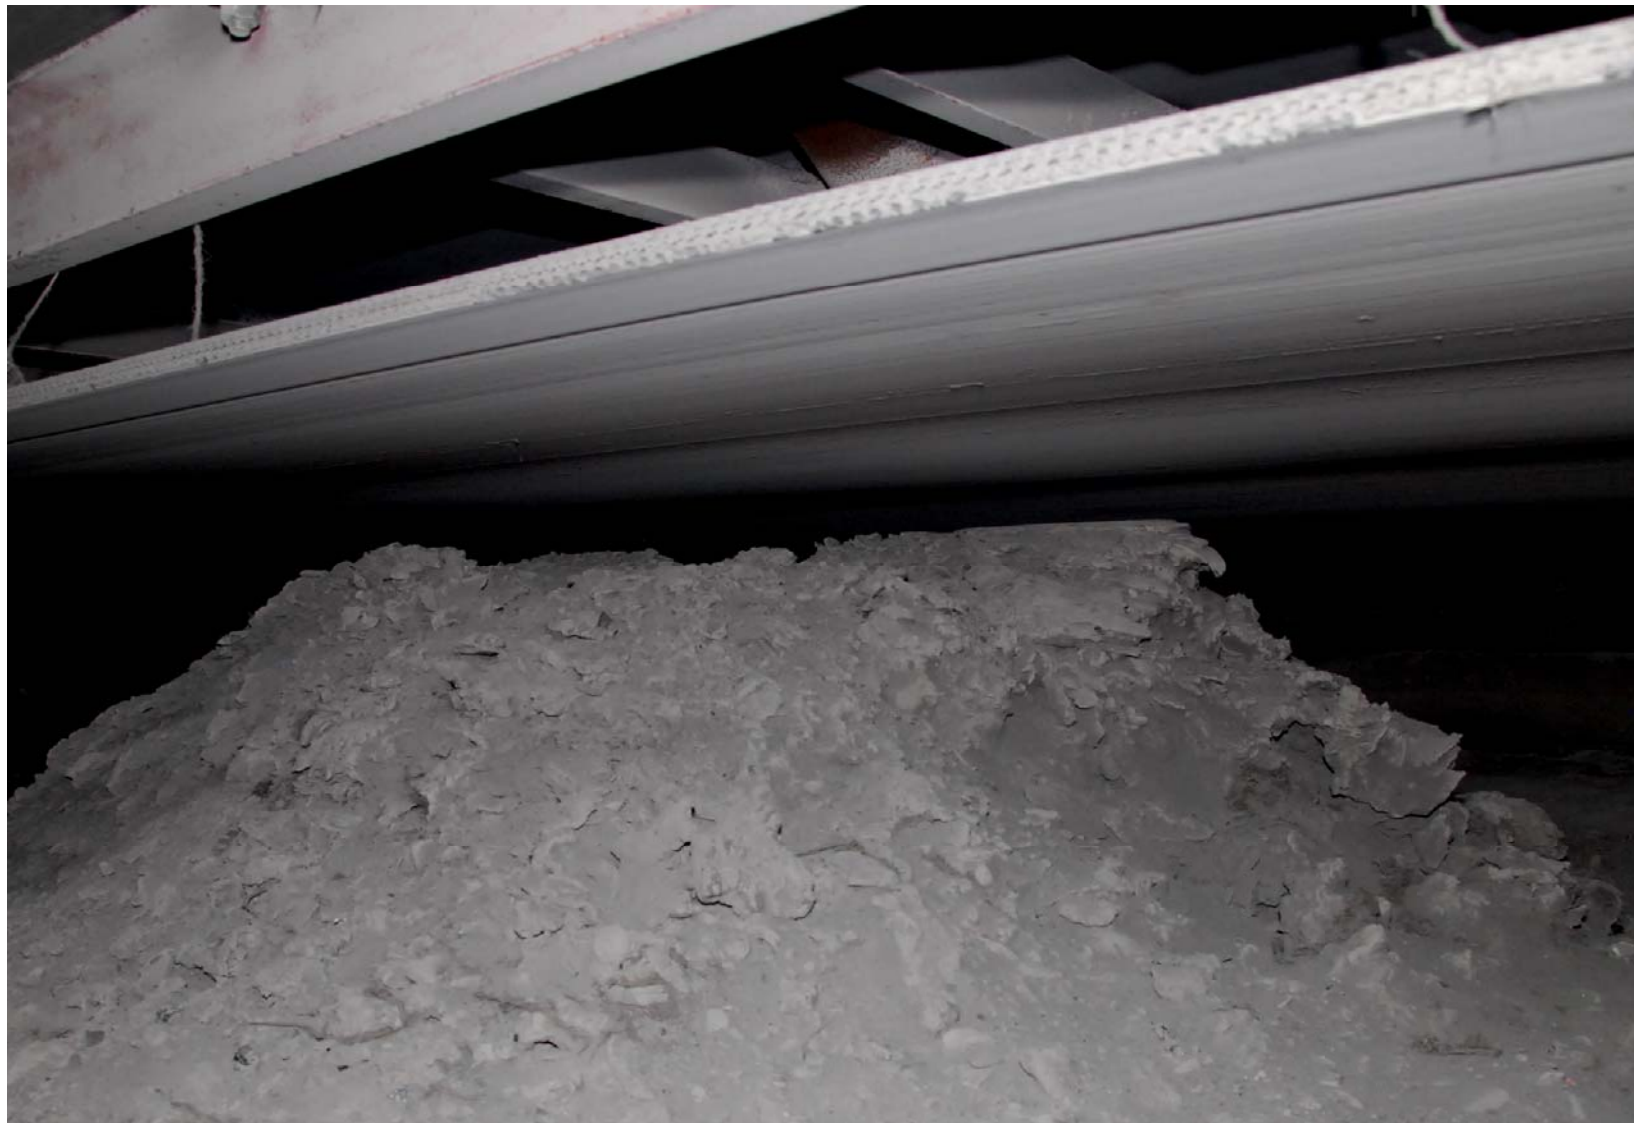
During the underground investigation, MSHA identified accumulations in over 50 locations along the conveyor belts. These accumulations were allowed to pile up below and around the belt and belt structure, and along portions of ribs that were not cleaned up during initial development. Examples of this are shown in Figures 8 and 9. The size and number of these accumulations demonstrate that the hazards existed for a long period of time.

Figure 8. Accumulations of loose coal with the top of the pile flattened due to rubbing the moving belt.

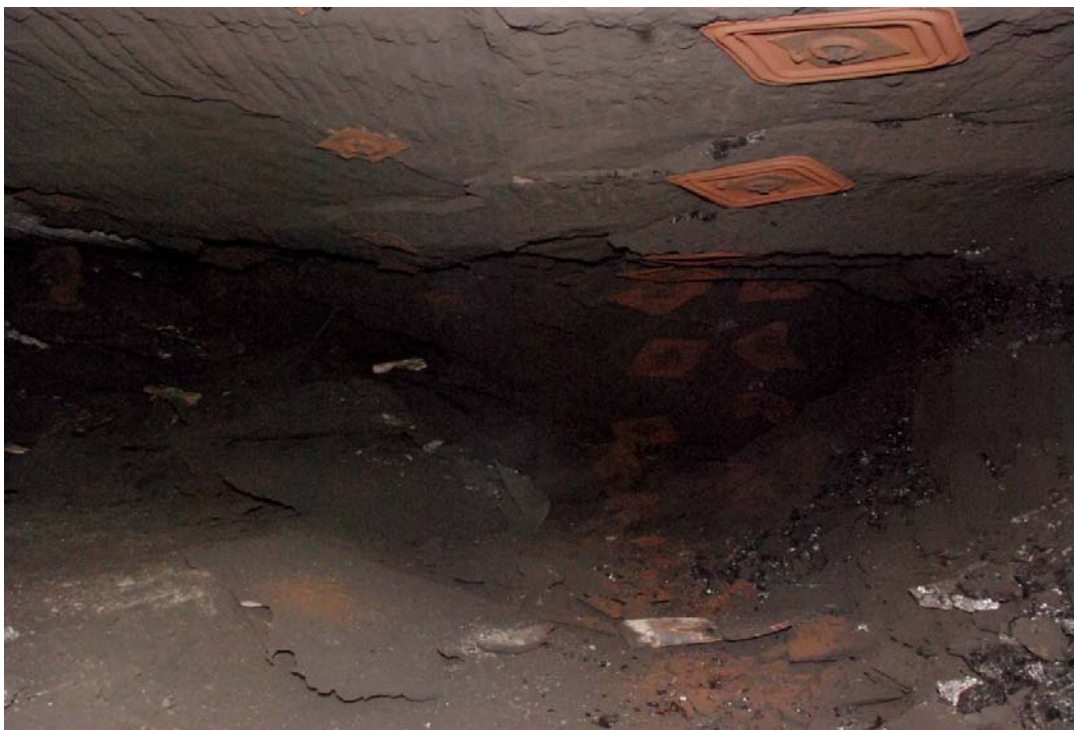
The failure to install appropriate tailgate support is significant because observations indicate that crosscut 49, the next crosscut inby the face, had already caved-in prior to the face reaching crosscut 48 and before the explosion based on debris on the fall rubble (Figure 23). PCC's failure to install either two rows of posts or two rows of eight foot cable bolts for support restricted the airflow in the tailgate entry inby the longwall face and contributed to the inability to adequately ventilate the tailgate area, which is discussed in the next section.

Figure 23. Caved roof in tailgate entry, as viewed in crosscut 49, which represents the next crosscut inby the face. Coatings of soot on the fallen rubble, juxtaposed against small pieces of freshly fallen, white sandstone, indicate that the intersection had caved prior to the explosion.

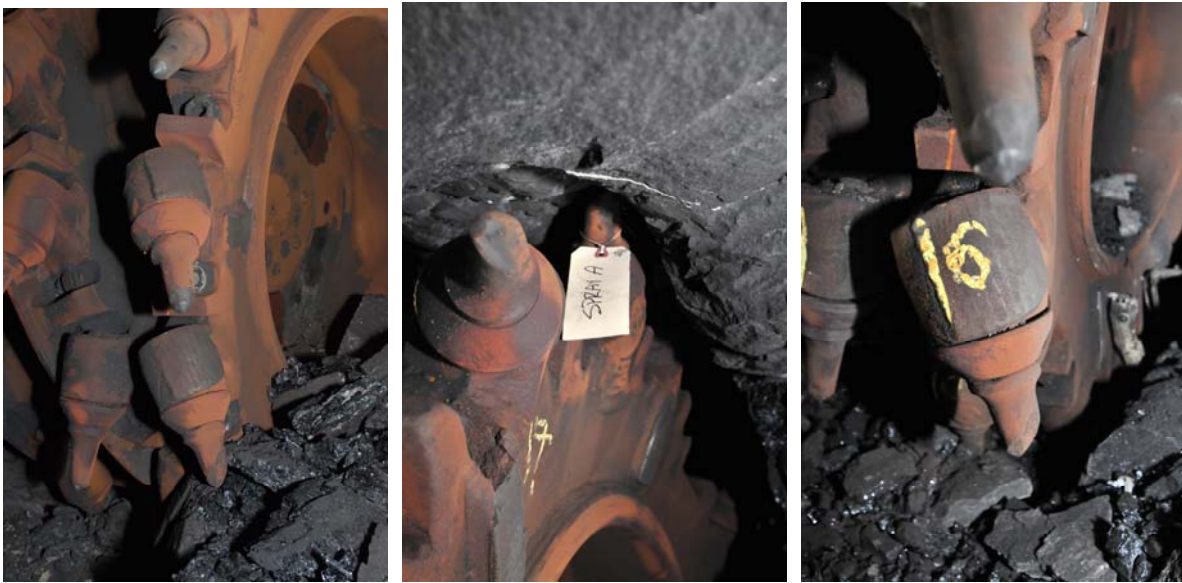
During the underground investigation, MSHA found that at least two cutting bits on the tail drum showed signs of excessive wear, including total erosion of the carbide tip and a large wear flat developed in the steel shank. One such bit is shown in Figure 30. Bits with large wear flats worn down to the steel shank striking quartz-rich sandstone, which is characterized by a high incensive potential, represents the most likely source of the initial methane ignition. While only a few bits were worn to the steel shank, one worn bit can provide an ignition source.

Figure 30. 1 North Panel tailgate drum, showing configuration of water sprays used in the pick-point flushing system. Note that sprays are directed toward the front of the bits, one missing water spray, and two bits exhibiting extreme wear.
